GENERAL PLAN

San Diego Coastal State Park System General Plan

Volume 4 - Leucadia State Beach

July 1984

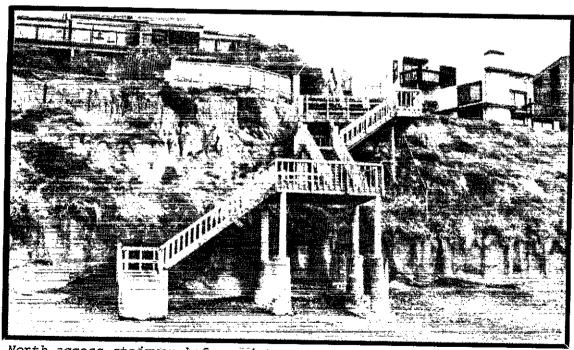
North access stairway before winter storms of 1982 and 1983

The northern pedestrian stairway (Grandview) was damaged on April 1, 1983 when an 82-foot section of the seacliff broke off from the bluff and fell onto the beach. As it fell, the massive block knocked down two flights of stairs and two landings of the Grandview stairway.

Area 1 -- The stairway was damaged in April 1983.

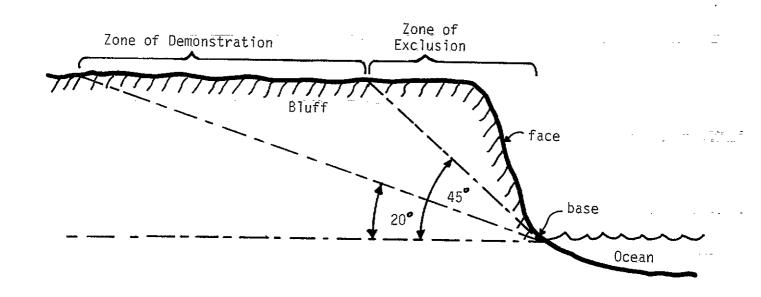
Figure 1

Zones of Demonstration and Exclusion
